**PFS TEST REPORT #05-74  
IMPACT LOAD TESTS  
FOR  
QUIET SOLUTION, LLC  
SUNNYVALE, CALIFORNIA**

PFS Test Report: #05-74  
Test Dates: 12/21 – 12/22/05  
Report Date: 12/28/05  
Page 1 of 10

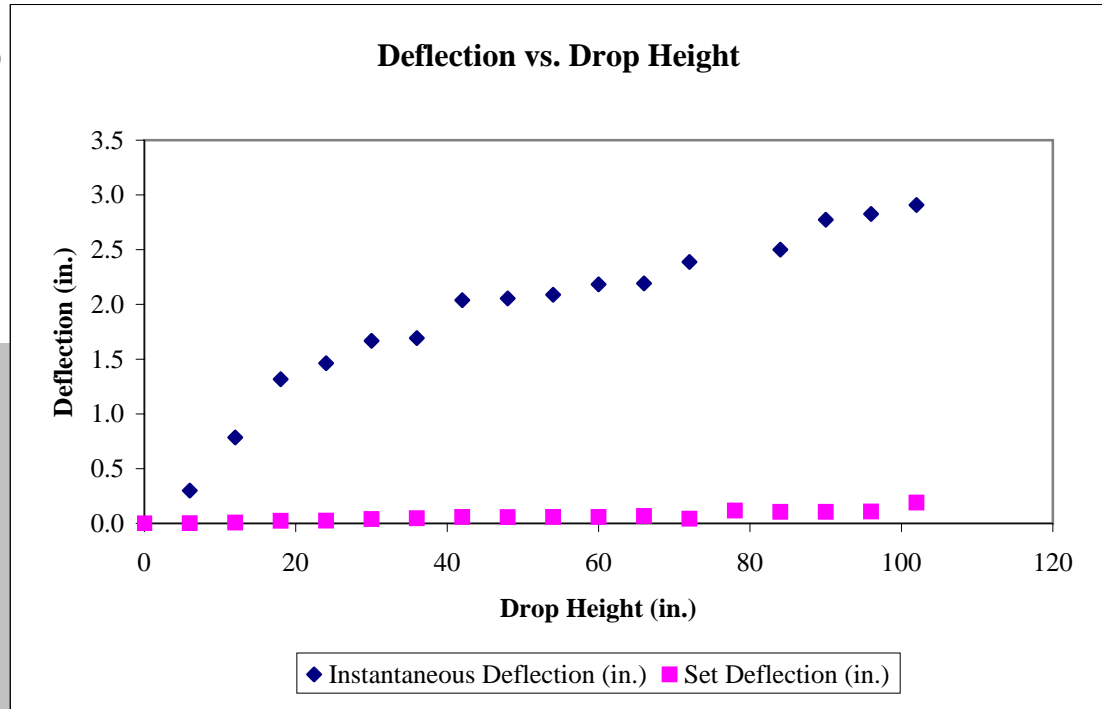
**Table 1**

**Observations:** Gauges recorded deflection on the back of the panel at the point of impact. After 24 in. drop, very thin cracking of the back panel. Cracks elongate with increasing height of drop. After 36 in. drop, very slight indentation on front face of panel. A 102 in. drop is the maximum achievable drop using this method. After 102 in. drop, there was a small wrinkle on the front face of the panel near the edge. Total depression at impact point was 0.257 in.

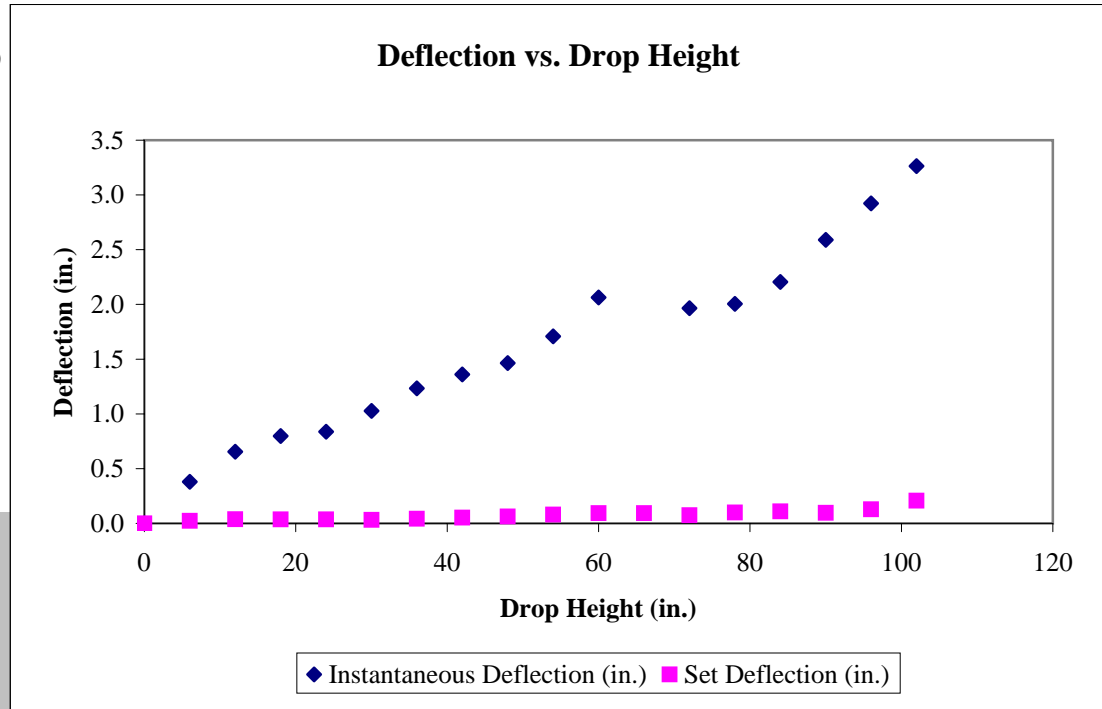
**Table 2**

**Observations:** Gauges recorded deflection on the back of the panel at the point of impact. First sign of cracking on the face after 66 in. drop. Only a slight depression at point of impact at conclusion of the test. Many fewer cracks in drywall than in Test 1.

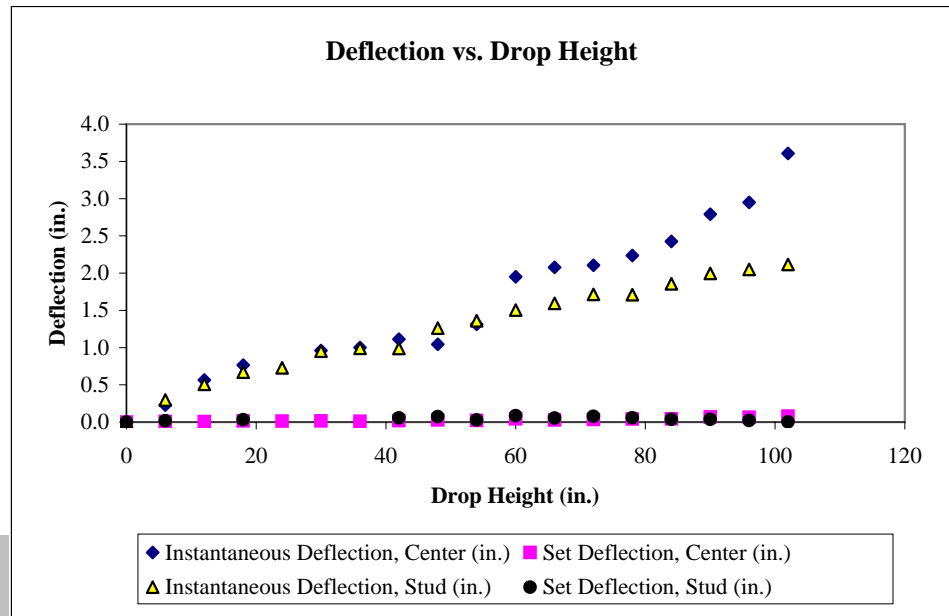
**Table 3**

**Observations:** Two sets of deflection gauges were used, one set on the stud opposite impact, and one set on the center of the panel, as in the previous tests. After 84 in. drop, there was a wrinkle on the face of the drywall near the edge, similar to Test 1. There was also a crack at the top of the stud on the edge of the panel. The wrinkle elongated with increasing drop height, to a final length of ~10 in. Slight cracking in the drywall on the back of the panel.

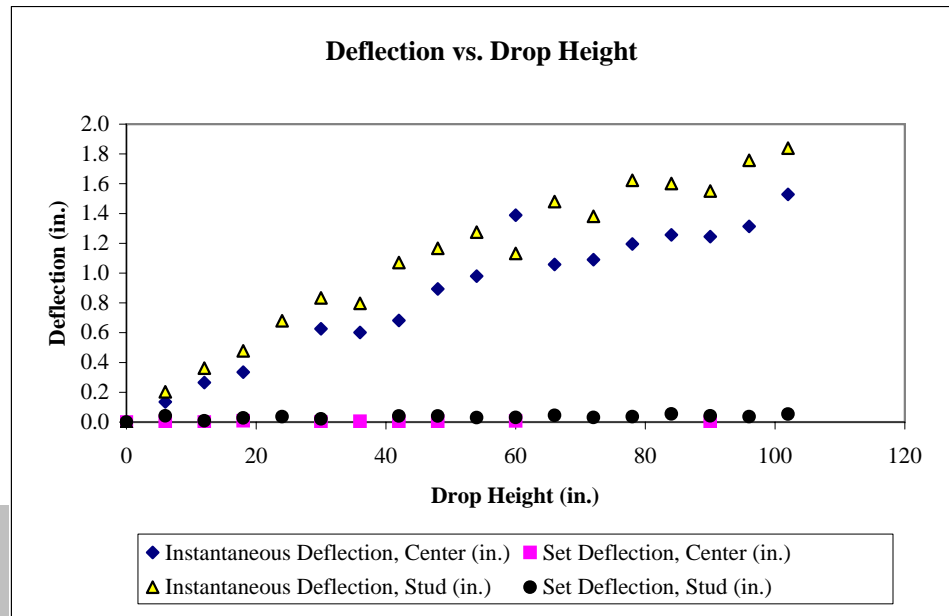
**Table 4**

**Observations:** Two sets of deflection gauges were used, one set on the stud opposite impact, and one set on the center of the panel, as in the previous tests. After 78 in. drop, the drywall was beginning to crack on the face side. After 84 in. drop, there was cracking on the face side along the screw heads.

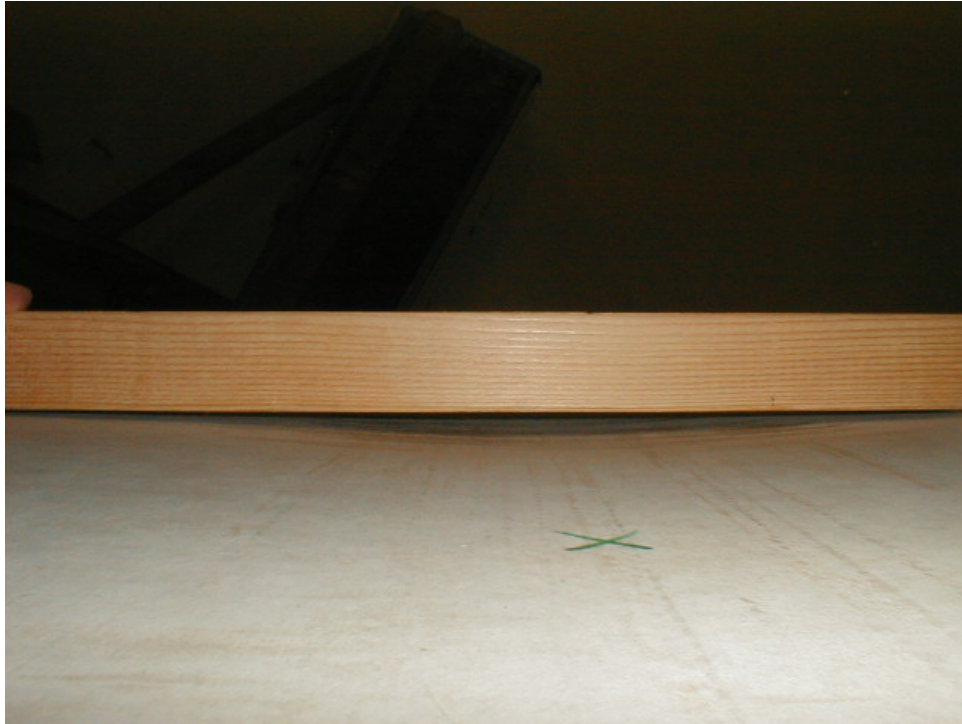
**Photo 2:** Indentation of panel at point of impact for the first test. The wooden slat being held across the panel is 1.5 inches tall.

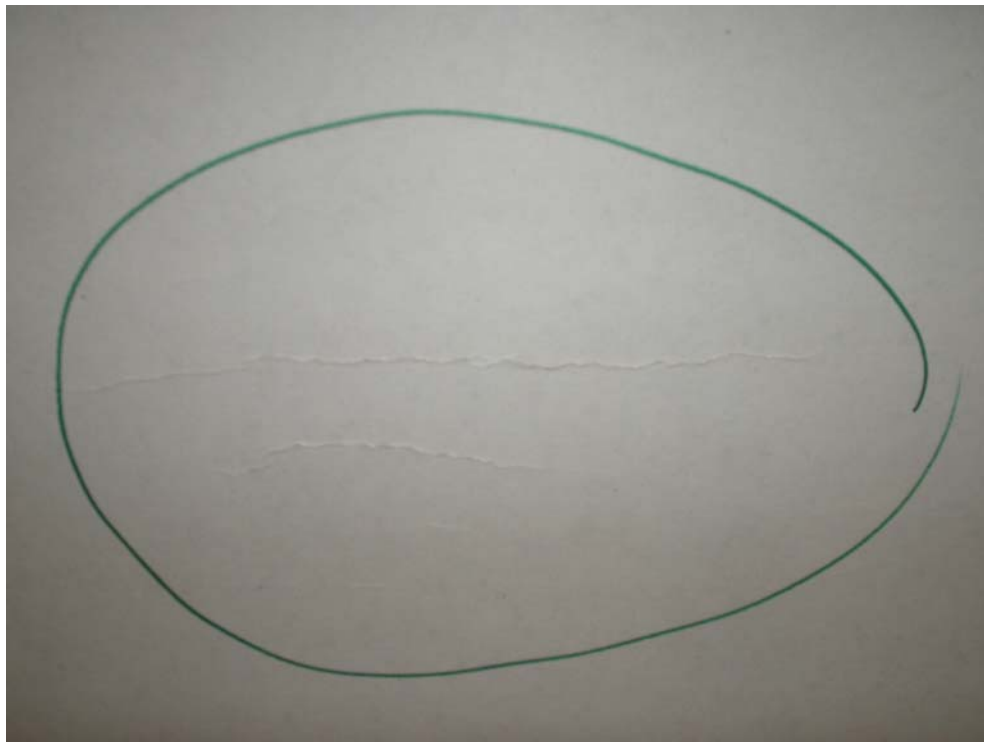
**Photo 3:** Cracking on the face of the panel after impact on the back during test two.

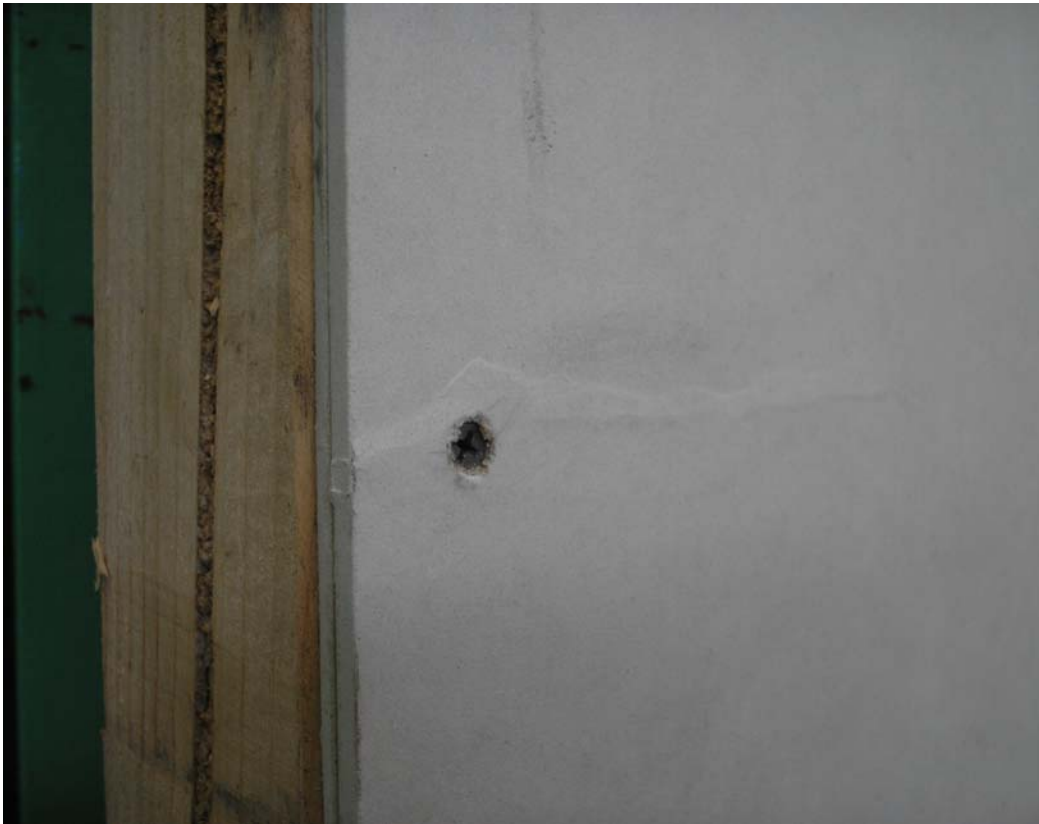
**Photo 4:** “Kinking” of the panel face during test three.

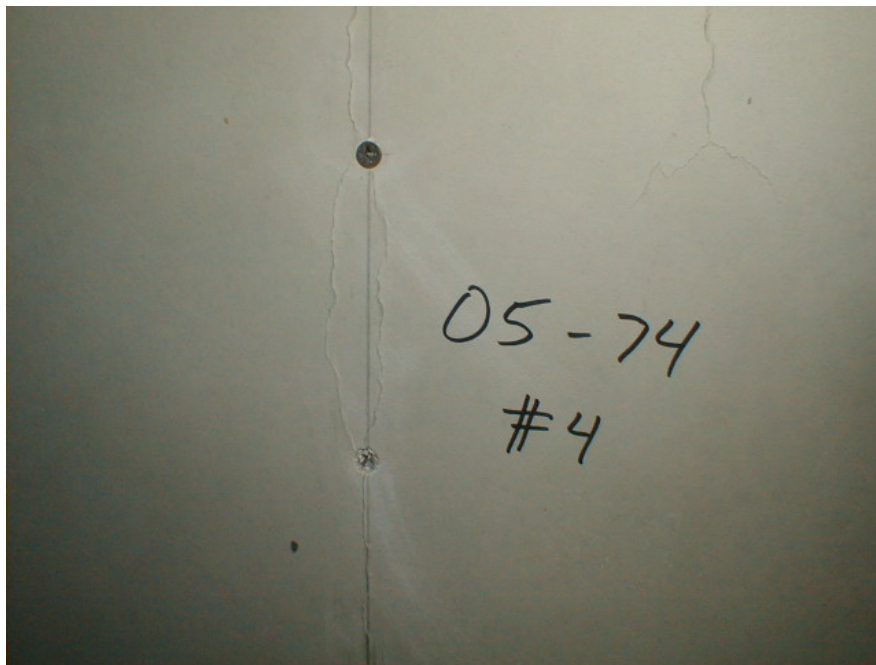
**Photo 5:** Cracking of the panel face along the stud line during test four.
